Document 30–III (Online Companion)

Cholera Inquiry Committee: “Mr. York’s Report”¹

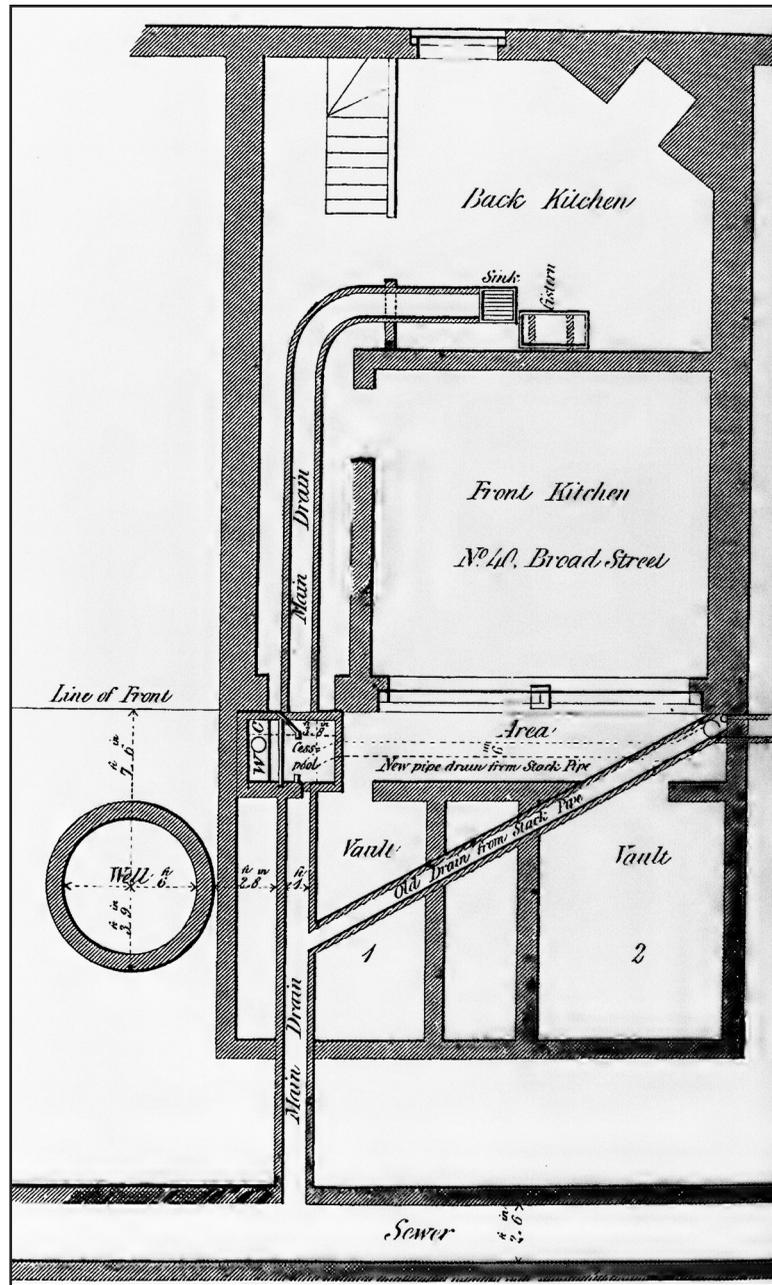
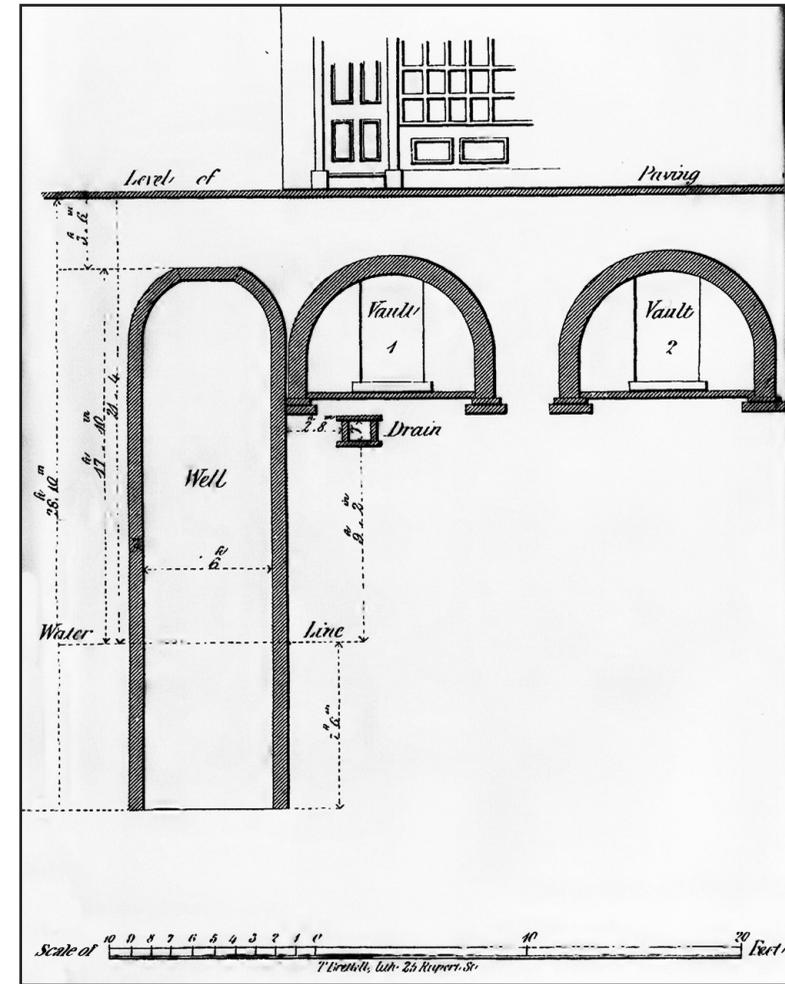
In connection with the question of how far any communication can exist, and has existed, between this defective drainage and the adjoining parish well which supplies the Broad Street pump, a reference to the accompanying plan and section of the well and drainage of the house will, I conceive, set the matter at rest.

From the bottom of the house drain down to the water line in the well, a vertical depth of 9 feet 2 inches exists. From the side of the drain horizontally to the outer side of the brickwork of the well, there is only a space of 2 feet 8 inches; the side wall of the vault adjoining the cesspool actually abuts upon it. Therefore, from the charged condition of the cesspool, the defective state of its brickwork and also that of the drain, no doubt remains upon my mind that constant percolation for a considerable period had been conveying fluid matter from the drains into the well. But lest any doubt should arise upon this subject hereafter, I had two spaces of the brick **steining**, two feet square each, [173/174] taken out of the inside of the well—the first, thirteen feet deep from the level of the street paving; the second, eighteen feet deep; and a third was afterwards opened, still lower. The washed appearances of the ground and gravel fully corroborated [my] assumption. In addition, the ground was dug out between the cesspool and the well to three feet below the bottom of the former. Its black, saturated, swampy condition clearly demonstrated the fact, as did the small, furrowed appearance of the underlying gravel observed from the inside of the well. The fine sand had been washed away during the process of filtration.

its egress from it was left. It had, in consequence, commenced to overflow between the back of it and the end wall of the area, [as well as] through any other crevice at the sides of the covering, which was composed of saturated rotten boards. The condition of this cesspool covering, together with the solid matter at the bottom, led me to believe that it must have been in this state for many months. It could not possibly have gone on much longer without total stoppage. All this old drainage has been removed. The cesspool [was] destroyed. New, tubular pipe drains with [172/173] cemented joints and a **syphon trapped** [water] closet have been substituted. The drain inside of the house which leads from the front area to the back kitchen has not been disturbed. It appears to be used only for the carrying off of waste water from a sink near the cistern. Should the street pump continue to be used hereafter, it will be necessary to have this drain reconstructed.
